2006 Annual Inspection Report for the Grand Junction, Colorado, Site

Summary

1.0 Introduction

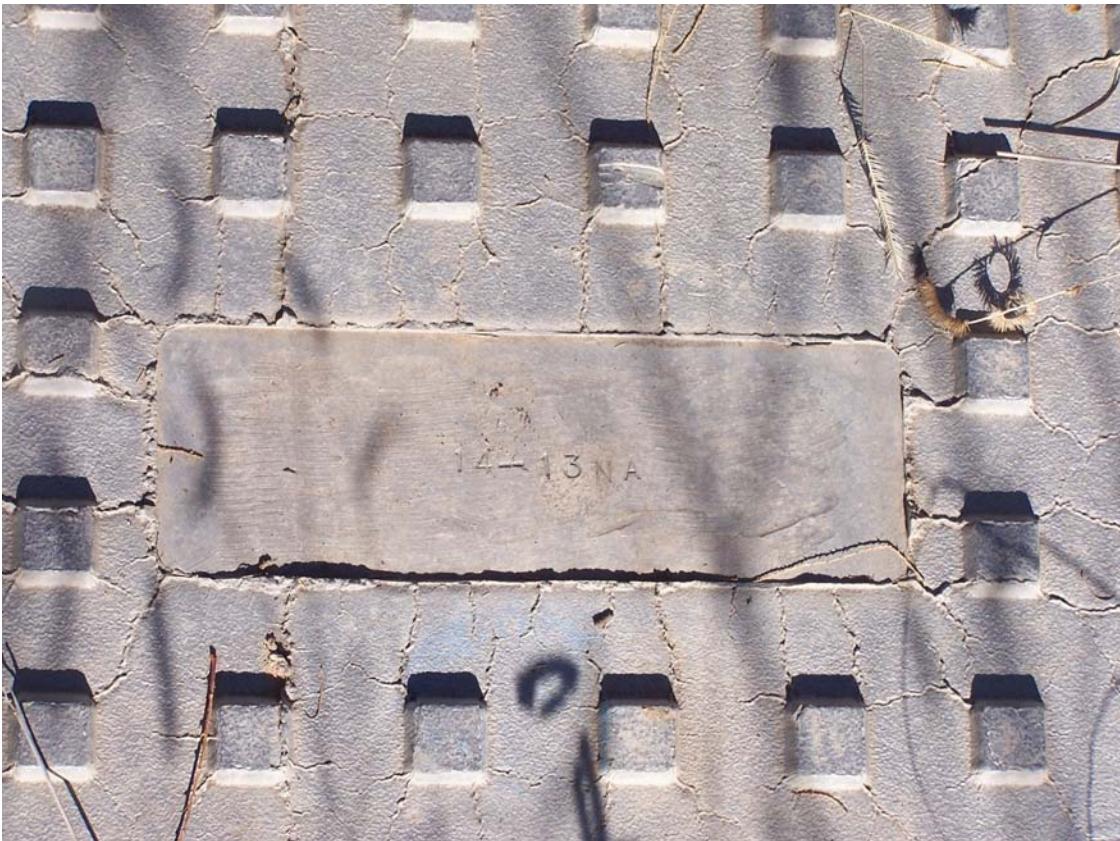
Monitor Wells—DOE owns eight monitor wells on the property to monitor the progress of natural flushing of contaminants from the alluvial aquifer. The wells are sampled annually. Inspectors found the visible portions of all wells in good condition, and all wells were secure. Identification numbers were stamped on the lids of all of the flush-mounted wells since the last inspection (PL-1). Signs for flush-mounted wells 10-19N and GJ84-04 had been removed prior to the inspection because they were damaged and no longer needed for identification.

GJO 2/2006. PL-1. Stamped identification number on the cover of monitor well 14-13NA.

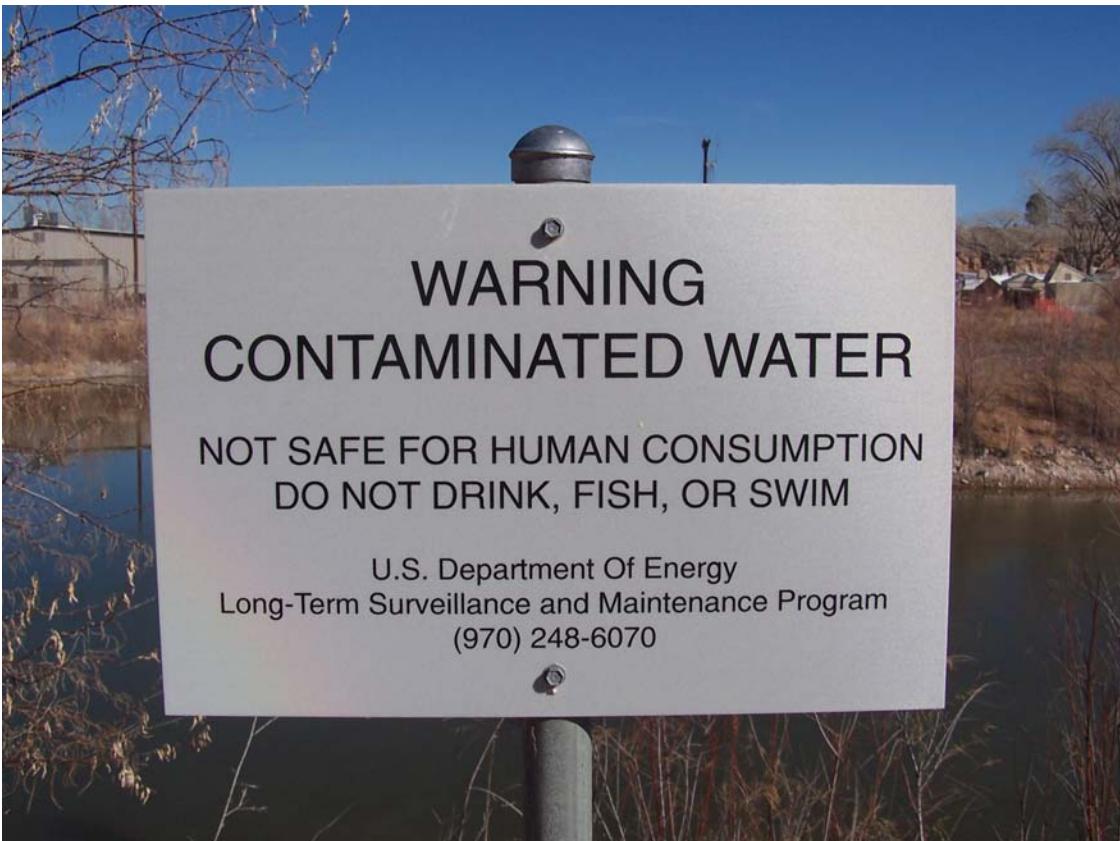
Warning Signs—Thirteen warning signs installed on galvanized steel posts are positioned around the surface water areas so the warning will be visible to a person approaching from any direction of reasonable access. Dense vegetation or fences block access to portions of the surface water occurrences. All signs were in excellent condition. Metal caps were installed on the signposts since the last inspection to inhibit rusting and prevent freeze damage (PL-2).

GJO 2/2006. PL-2. Warning sign S2 located on the west side of South Pond.

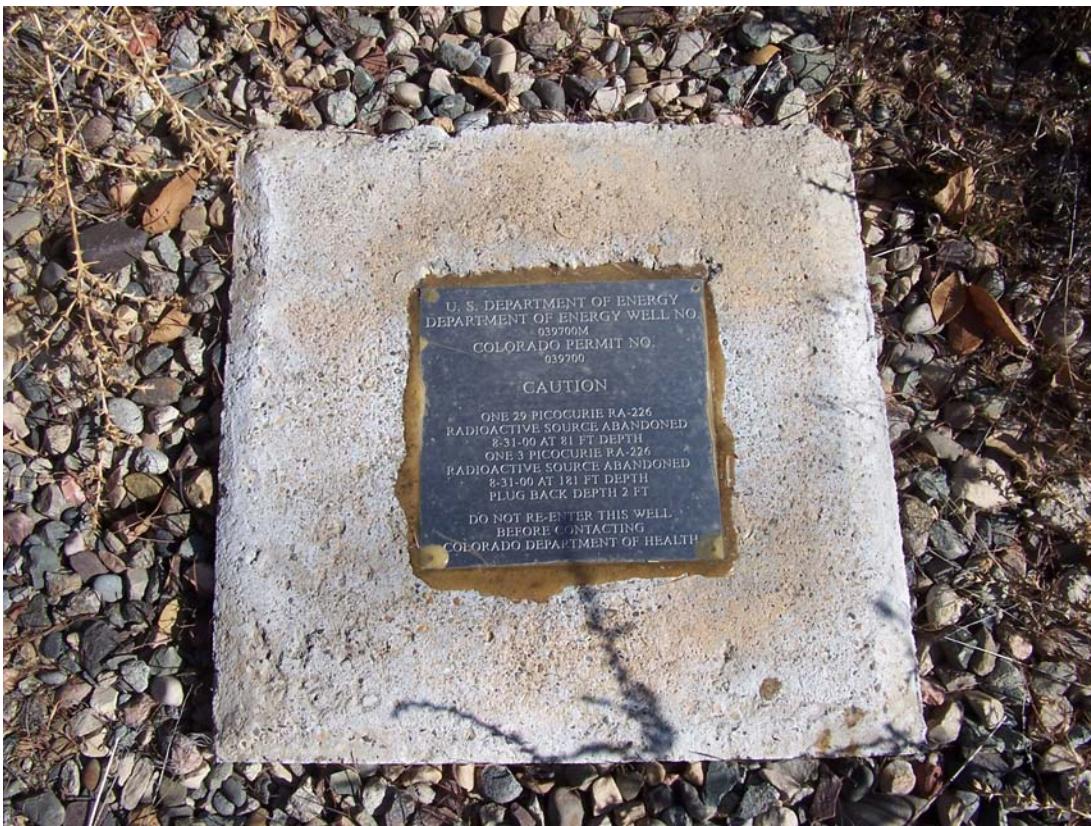
The borehole was decommissioned in place in 2000. DOE perforated the casing above and below each strip of foil and pressure-grouted the annulus with Portland cement to seal the foil in place. The borehole was filled with grout, and a metal plaque was mounted in concrete at ground level over the well. Borehole information printed on the metal plaque was fading and difficult to read at the time of the last inspection. A new metal plaque with the borehole information and warning engraved into the metal has been installed (PL-3).

GJO 2/2006. PL-3. Information/warning plaque on the sealed borehole containing radium foil.

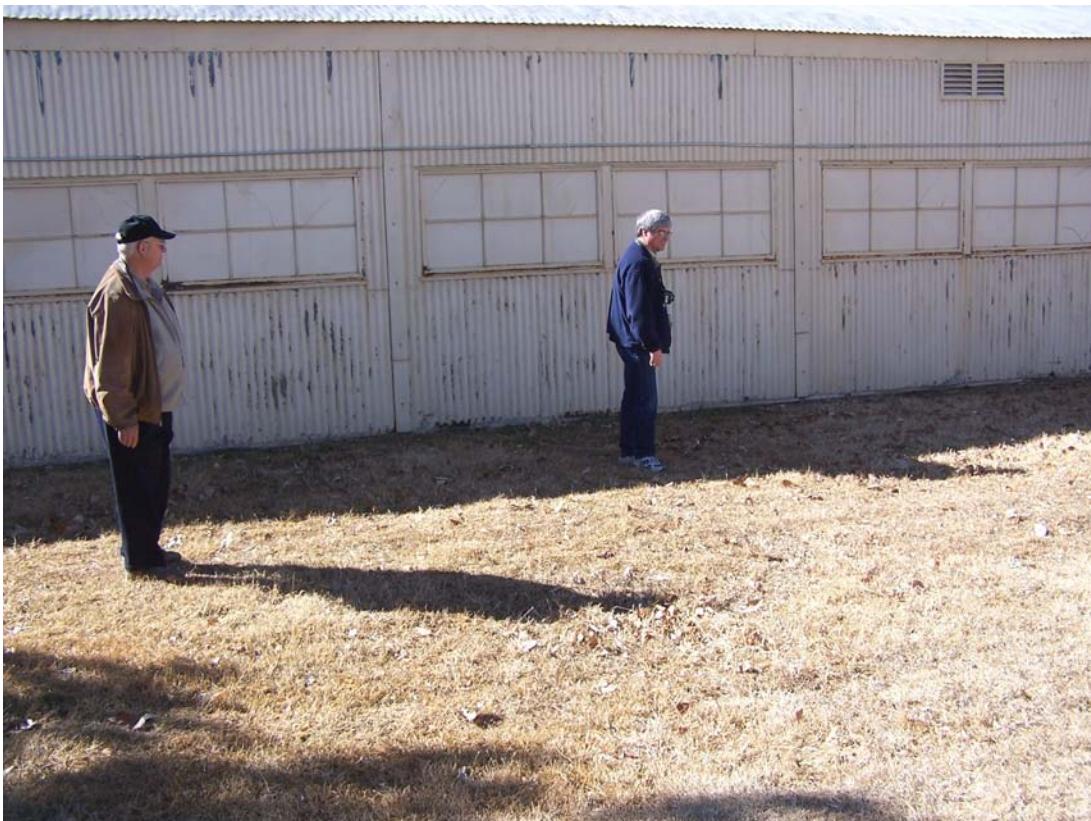
The interior floor area of Building 12A was inspected. There was no visual evidence of floor penetrations in the affected area since the last inspection, which was confirmed by the building manager. The interior of Building 20 was not inspected because it was undergoing asbestos abatement in preparation for building demolition. Exterior areas adjacent to the contaminated media under both buildings have not been disturbed (PL-4 and PL-5). The current site owner controls maintenance activities in the exterior areas near the contaminated soil and DOE contractor personnel observe these exterior areas during normal working activities.

GJO 2/2006. PL-4. Area along the southeast corner of Building 12 adjacent to the location of the contaminated concrete slab under the building.

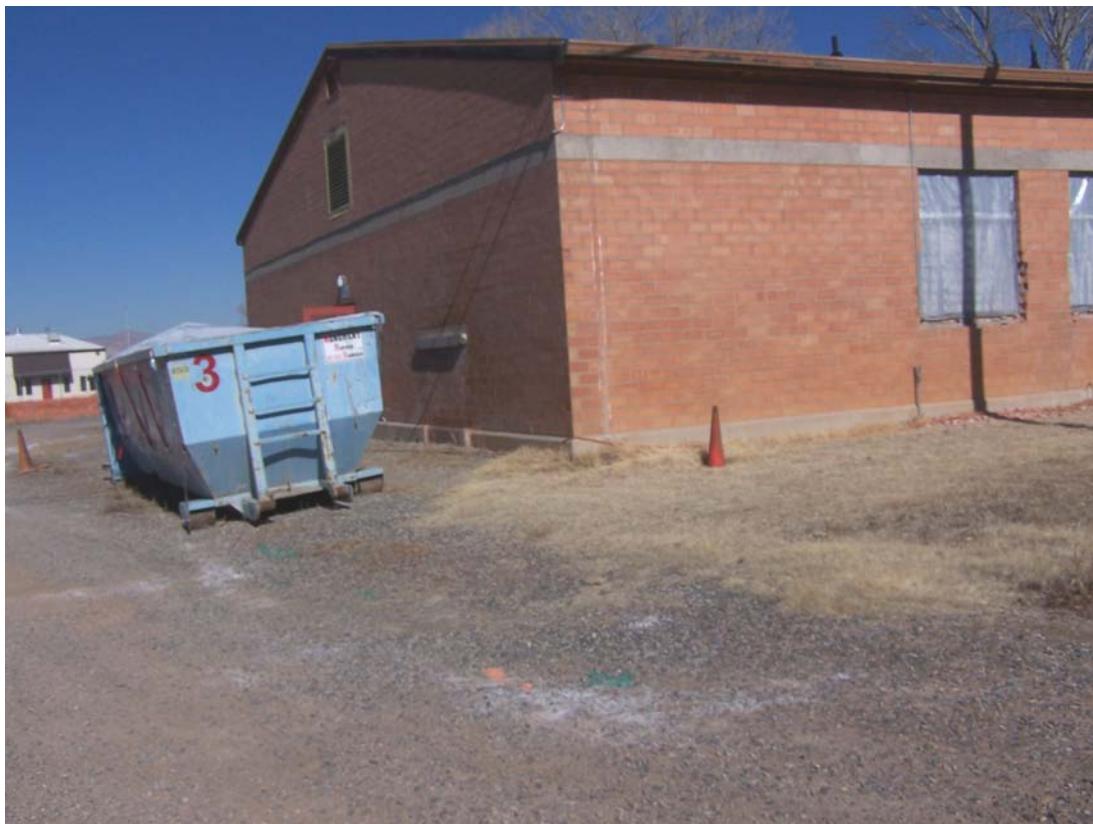
GJO 2/2006. PL-5. West end of Building 20 adjacent to the location of contaminated materials under the building.
